Cessna Wing Spar Reinforcement

FAA Public Meeting –Proposed Cessna Wing Spar AD 3-4 March 2004 – Washington D.C.

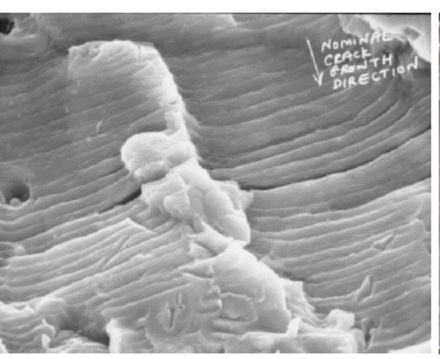
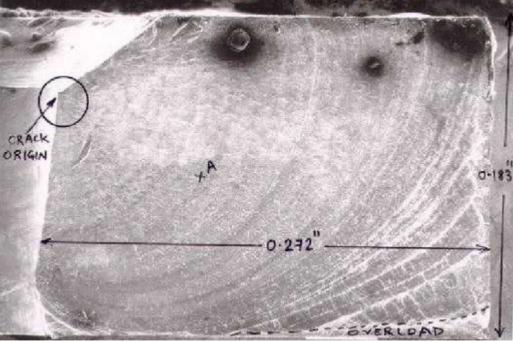
Fatigue Fracture Face

Fatigue Striations

Beach Marks

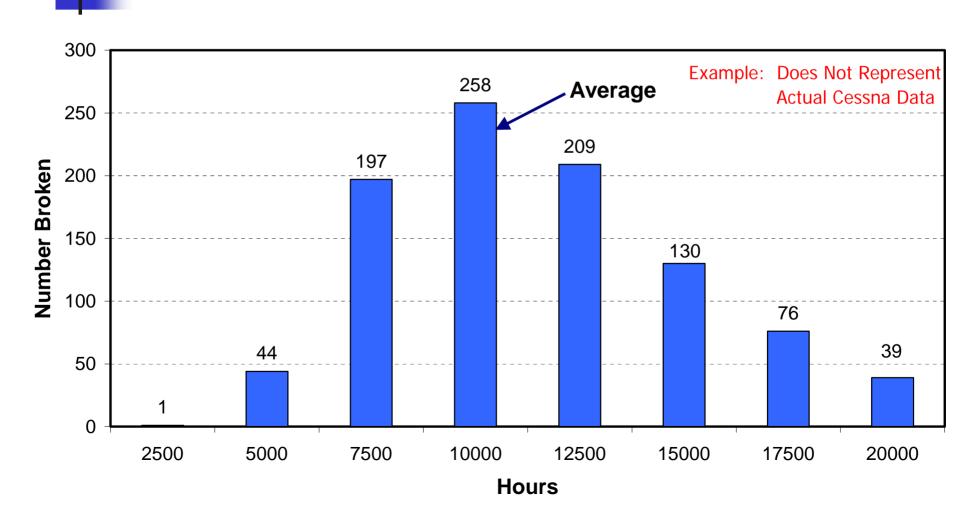
1000 Wing Spars Fatigue Tested

- Suppose 1000 identical wing spars were fatigue tested with the same loads
- Assume the average wing spar breaks at 10,000 hours
- They won't all break at the same time

- First wing spar will break at 2,500 hours
- Last wing spar won't break until after 120,000 hours
- The problem is that we don't know beforehand which one will break first
- When is action required?
- What level of risk do we accept?

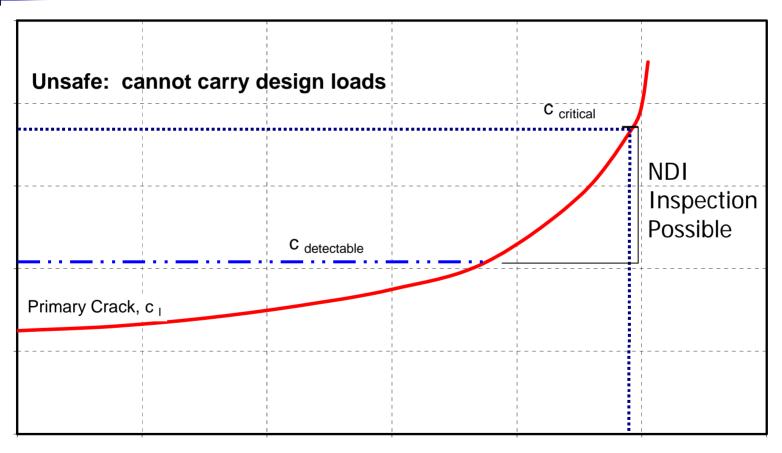
Crack Growth Analysis

Flight Hours

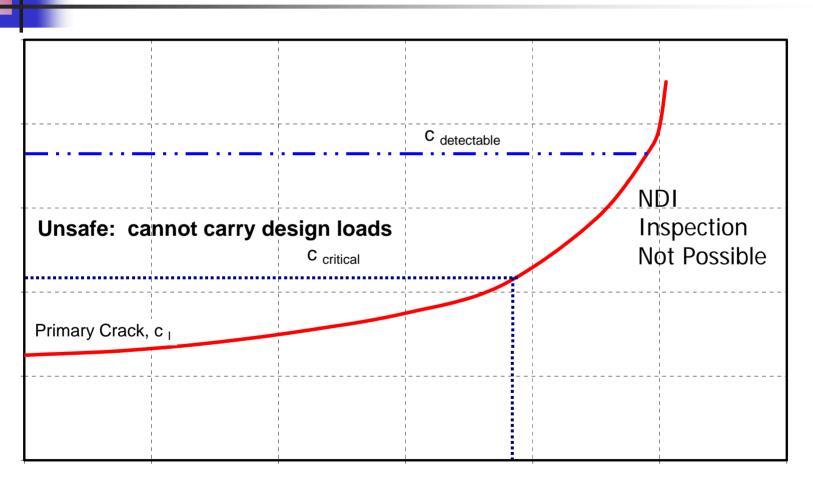
Crack Growth Analysis

Crack Length (inches)

Flight Hours

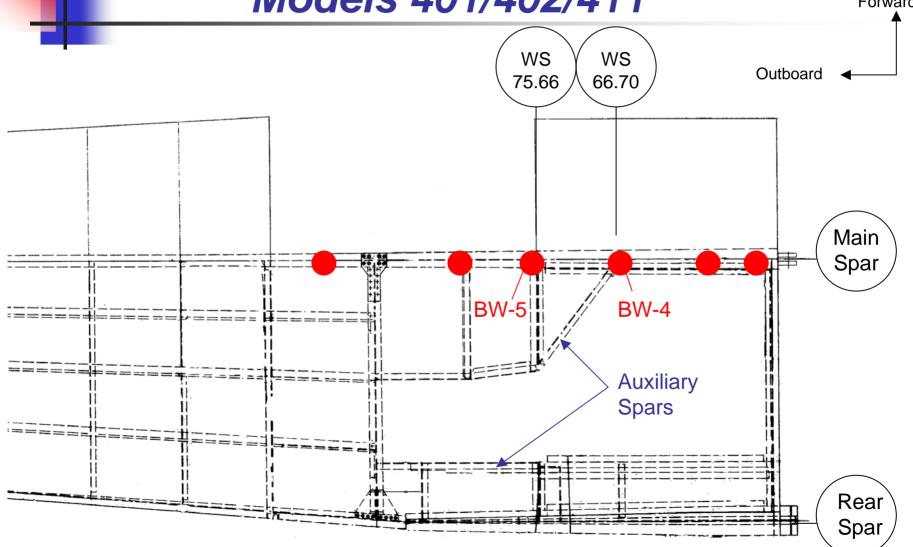
Main Spar Analysis Locations Models 401/402/411

- Models 401, 402, 411
 - Basis of life limits in Australia and United Kingdom
 - Lowest fatigue life is BW-5, WS 75.66
 - Second lowest fatigue life is BW-4, WS 66.70

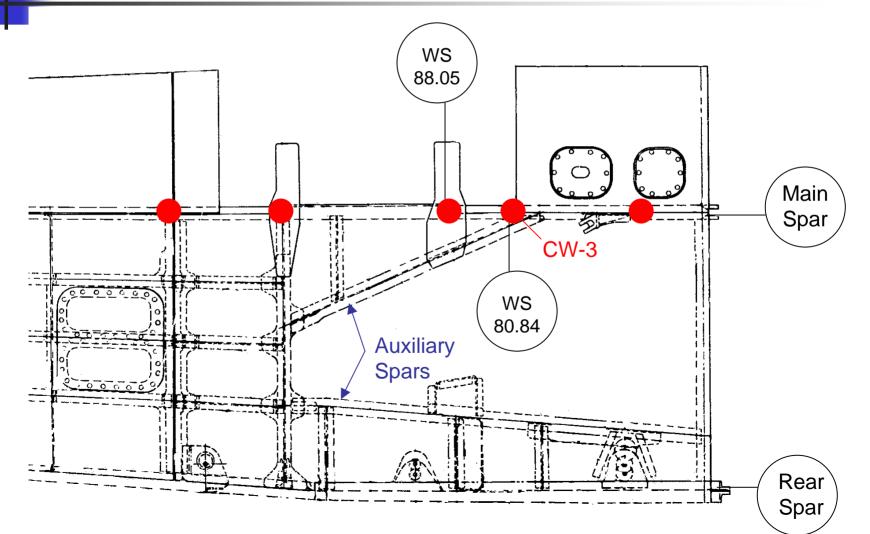
- Models 402C and 414A
 - Basis of life limits in Australia and U.K.
 - Lowest fatigue life is CW-3, WS 80.52

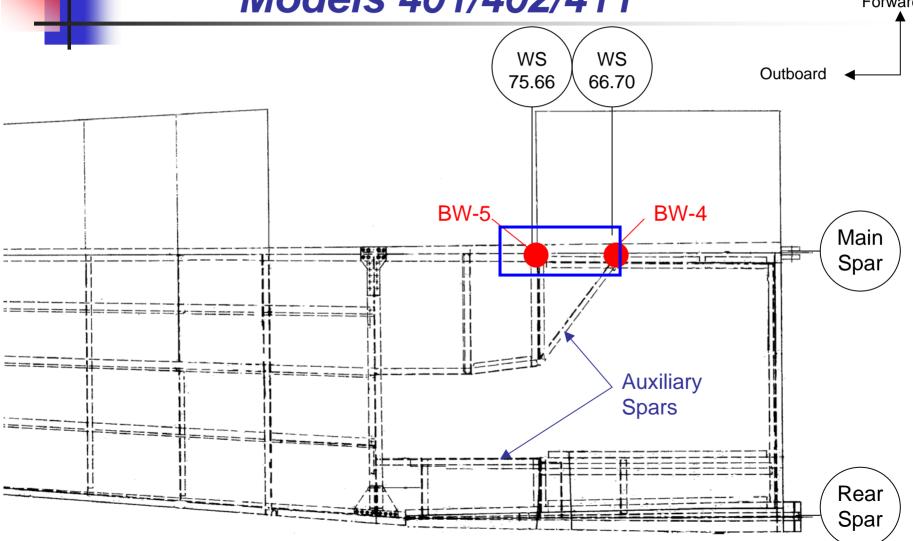
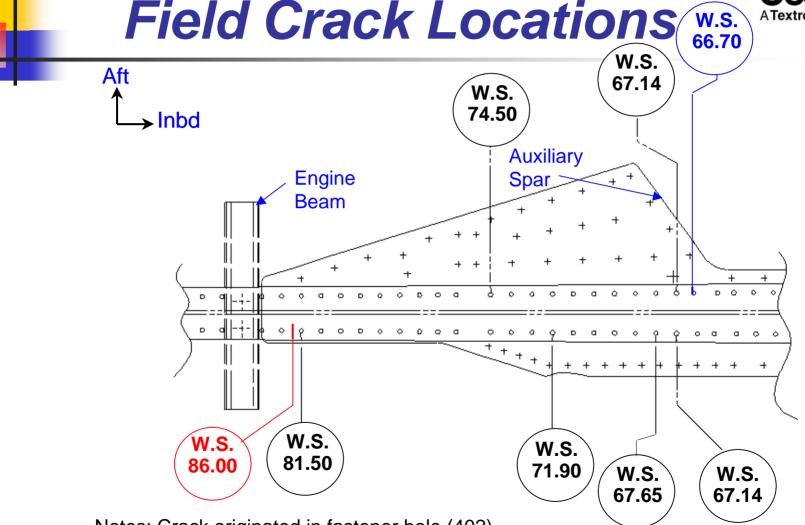
- The accuracy of the analysis is further supported by field history
 - Spar cap cracks have been discovered on six Model 402 airplanes
 - Five cracks were between WS 66 and WS 75 (analysis locations BW-4 and BW-5)
 - Sixth crack was at WS 81
 - Four instances were complete spar failure
 - Cracks were found between 8000 and 16,000 hours
 - All these airplanes were utilized in commuter service at the time the crack was found

- One spar cap failure on Model 402C
 - Crack found after 20,400 hours
 - Crack located at WS 86.00, five inches from analysis location CW-3
 - This airplane was used to carry cargo at the time the crack was discovered

Notes: Crack originated in fastener hole (402)

Crack originated at spar cap edge (402C)

Fatigue test crack origin (reference)

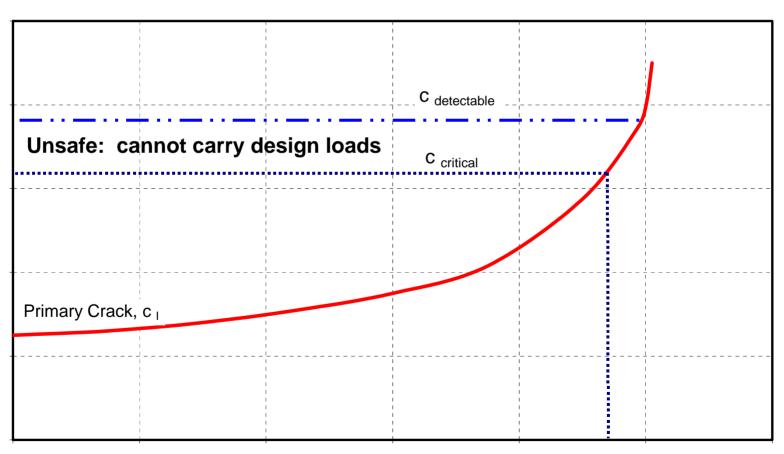
Crack Growth Analysis

- The industry standard is to find a crack with 90% probability of detection with 95% confidence
 - Surface eddy current method (per ME79-16 and AD 79-10-15) won't find crack until it is .19" which is .03" longer than the crack length which will no longer allow the spar to carry limit load
 - Once the spar is broken, the wing will no longer carry the required loads
 - Wing failure can occur in a very short period of time after spar cap breaks

Crack Length (inches)

Flight Hours

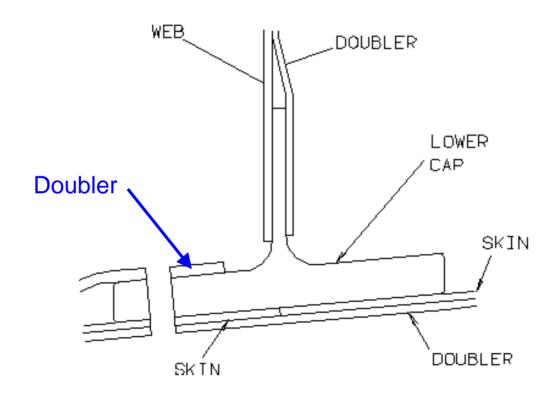
Doubler Over Spar Cap

- The eddy current procedure (per ME79-16 and AD 79-10-15) has been successful only once in finding a spar cap crack
 - Inspection was conducted by experienced Cessna NDI personnel
- Reliability of inspection is hampered since much of the main spar flange is covered by doublers
